University of Puerto Rico at Mayagüez
Faculty of Arts and Sciences
Department of Geology

Measuring Shoreline Changes in Rincon Beach Using Remote Sensing Techniques

Pablo R. Mejías-Santiago
#802-05-4749
GEOL 4049
Advisor: Dr. Fernando Gilbes Santaella

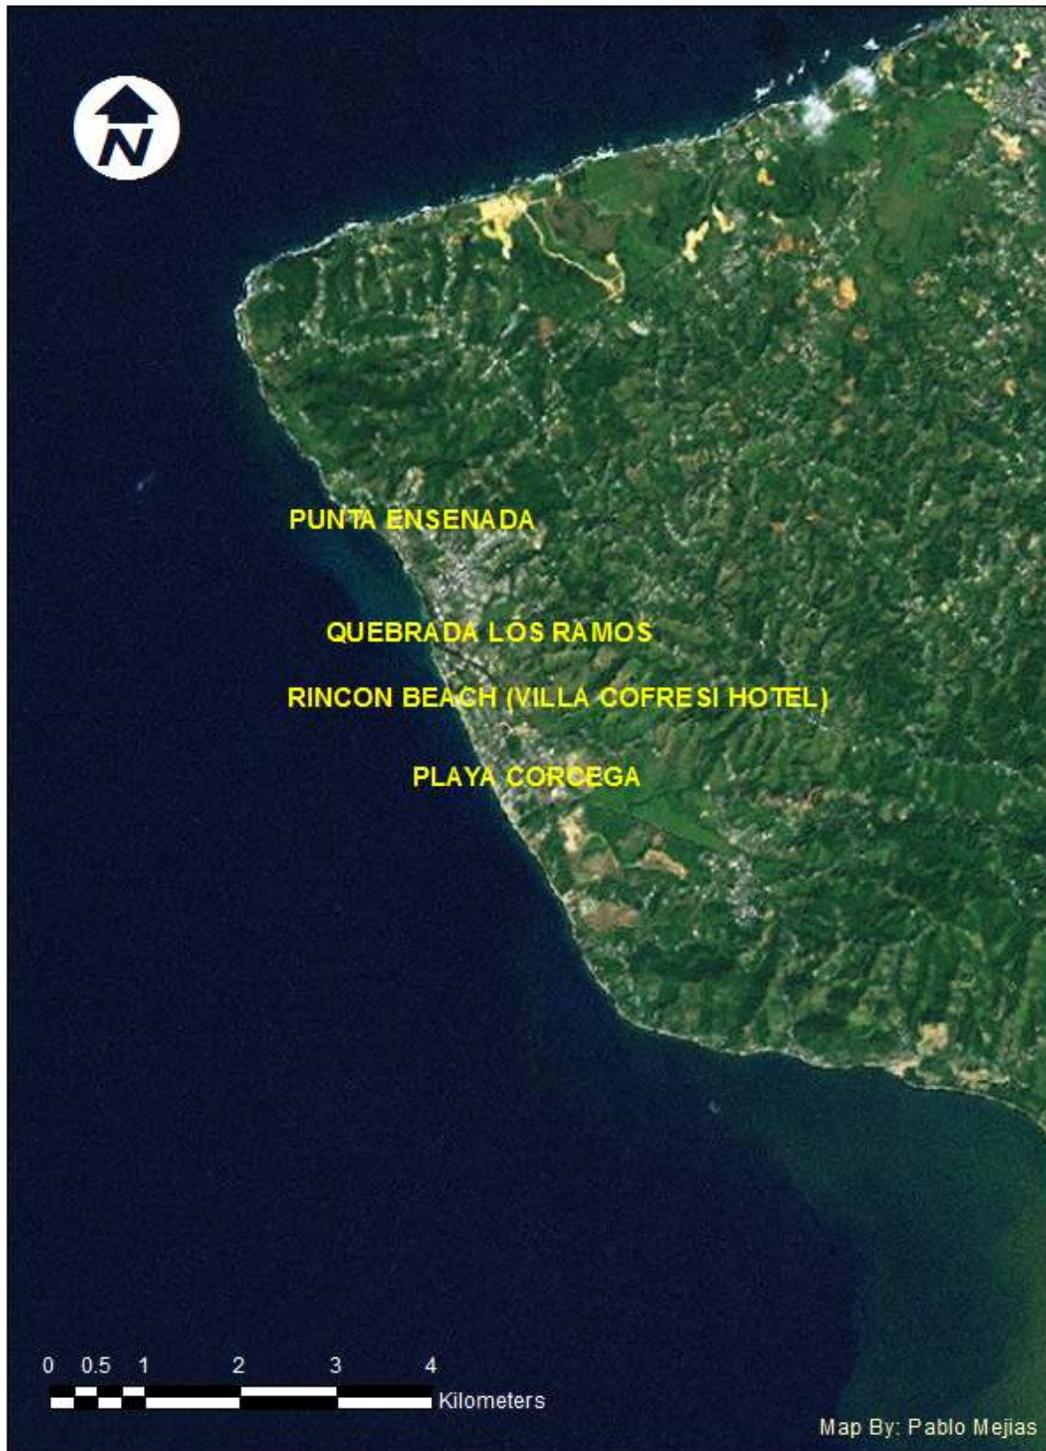
Figure 1: Transect Location. Rincon, Puerto Rico

This proposed work is part of a comprehensive study that takes place in the coastal area of Rincon, Puerto Rico (figure 1), which is an area with high vulnerability and risk. The main objective of this research is to interpret the recognition of historical aerial photos and satellite using remote sensing techniques to study changes in coastlines in Rincon Beach. This work includes fieldwork observations to be analyzed for a preliminary hypothesis than that obtained by analysis of aerial photographs and satellite images from a different range of years. This research is mainly focused on the usage of latest remote sensing techniques and in-situ observations to measure shoreline changes in the Villa Cofresi Beach in Rincon, Puerto Rico. The Villa Cofresi Hotel, built in the decade of 1960's, had one of the most attractive beaches in the western coast of Puerto Rico (Scott, 2010). Today, this beach has no sufficient sand and recreational facility between hotel's main building and the coastline (Scott, 2010). The hotel administration has tried to stabilize the beach artificially building a rigid wall (Scott, 2010) to protect the building from waves and erosion, especially during bad weather conditions.

A total of seven (7) GPS points were selected in a 400-meter transect from Punta Ensenada to Playa Corcega north to south respectively to measure shoreline changes supported by the latest remote sensing techniques and in-situ observations (figure2) based in previous studies performed in this zone. Using aerial pictures from years 2007 and 2010 we can determine and compare shoreline changes in Rincon Beach. The integration of these tools can help us to determine a long-term risk to the coastal zone and it contributes to strengthening risk assessment caused by coastal erosion (Gornitz, 1991), affecting a better quality of life and sustainability of the affected area and coastal community.

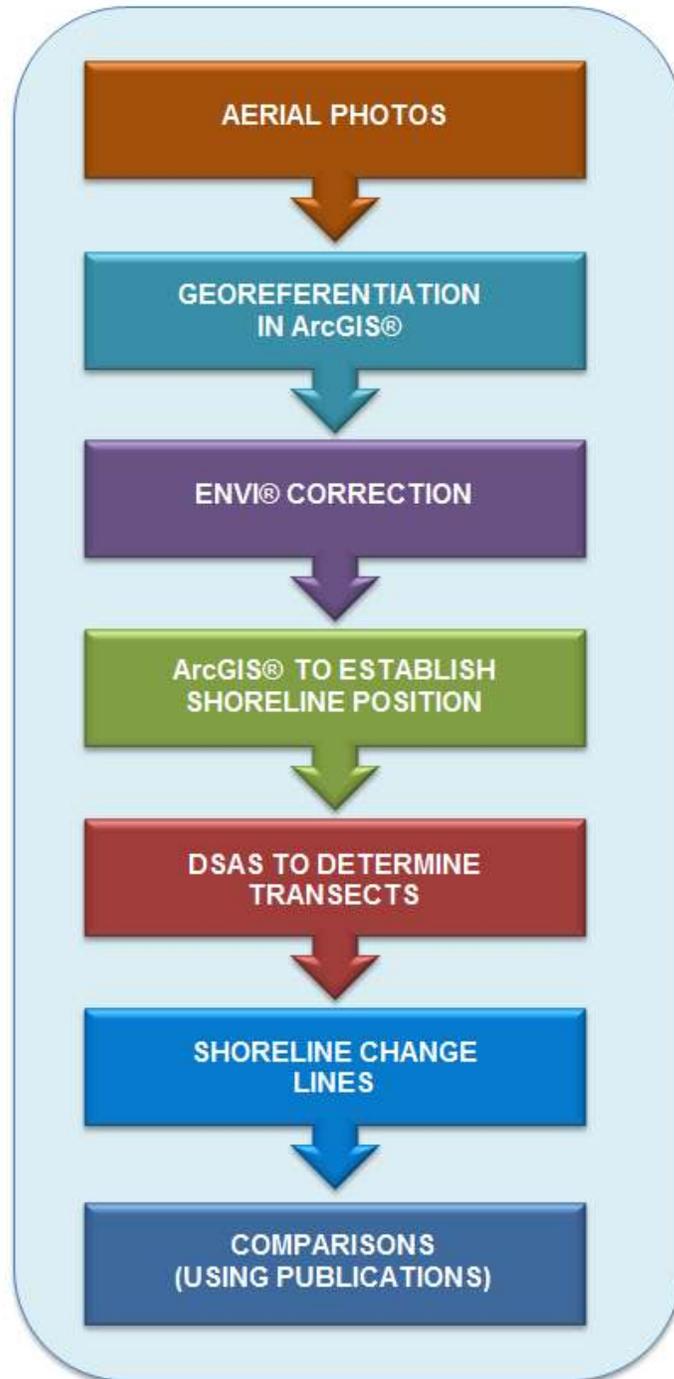
Figure 2: Methodology flow chart. Processes before obtain final results.

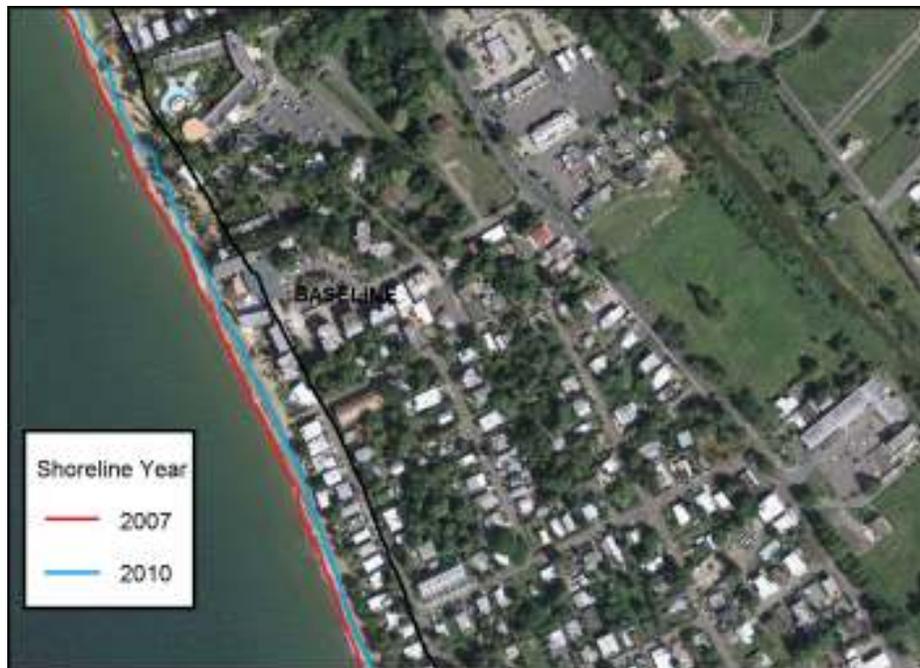
Figure 4: DSAS Final results. Shoreline changes can be seen. GERS Laboratory.

To get better results this study is conducted using the Geological and Environmental Remote Sensing Laboratory (GERS). This research is widely supported by using ArcGIS Version 10 (figure 3) and its free software extension of Digital Shoreline Analysis System (DSAS) version 4.4 (Thieler et al. 2003) (see figure 4). This extension is a very useful tool to conduct studies of shoreline changes, and generates a series of transects (See Figure 1), with the selected spatial interval to compare different shorelines at a different range of time (Thieler et al. 2003). ENVI software (figure 5) was an excellent tool to determine sharpness and colors for the aerial pictures.

After analyzing results of field observations and computer-aided modeling using aerial pictures and satellite images, we can observe that Rincon Beach is suffering degradation of shoreline at a very fast rate (Thieler et al. 2007). DSAS model shows clearly a change in shoreline from 2007 to 2010. This change is realized due to several triggers described in the discussion/interpretation section. Another robust evidence of shoreline change and coast degradation in this area is shown when field observations (pictures from 2007 to 2012) reveal a similar result as DSAS predict. When we observe DSAS projection lines, the 2010 line (blue) is inner (inland) and closer to the coast structures. According to Thieler et. al, 2007, their job is validated and continued with this recent research. A collection of field pictures is provided in the appendix section.

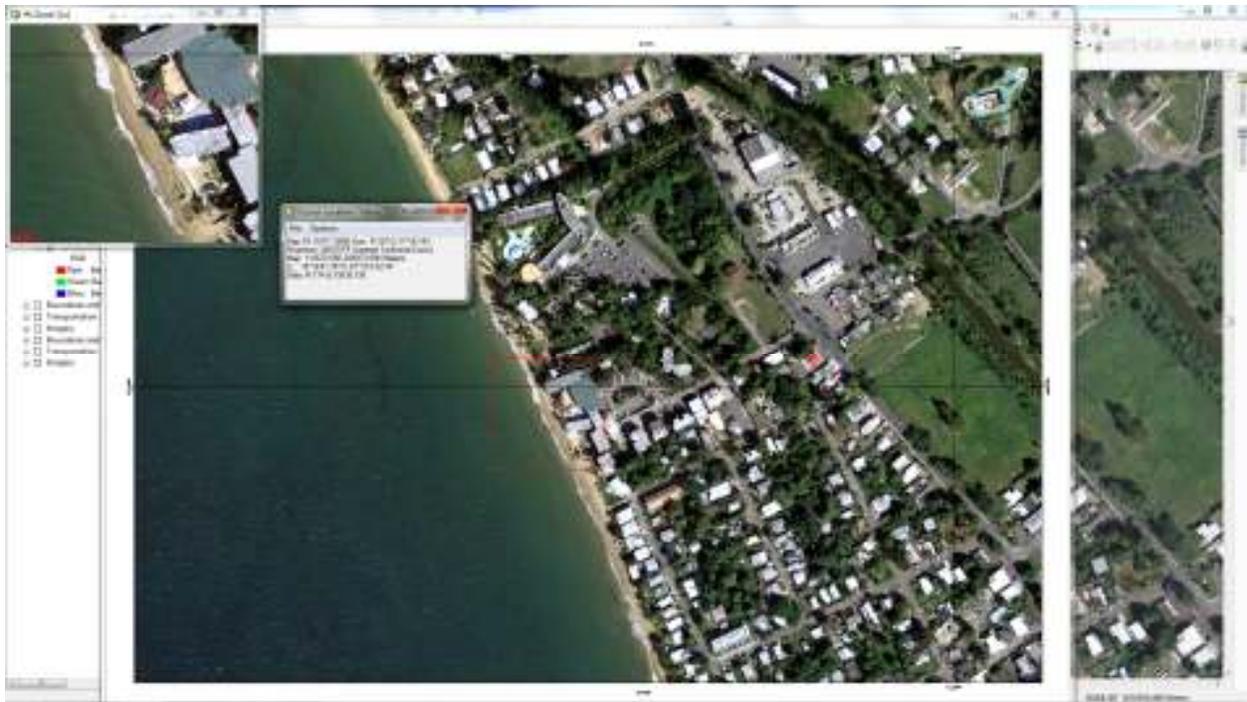
Figure 5: Screen example of ENVI software. Used to improve colors and more detailed features.

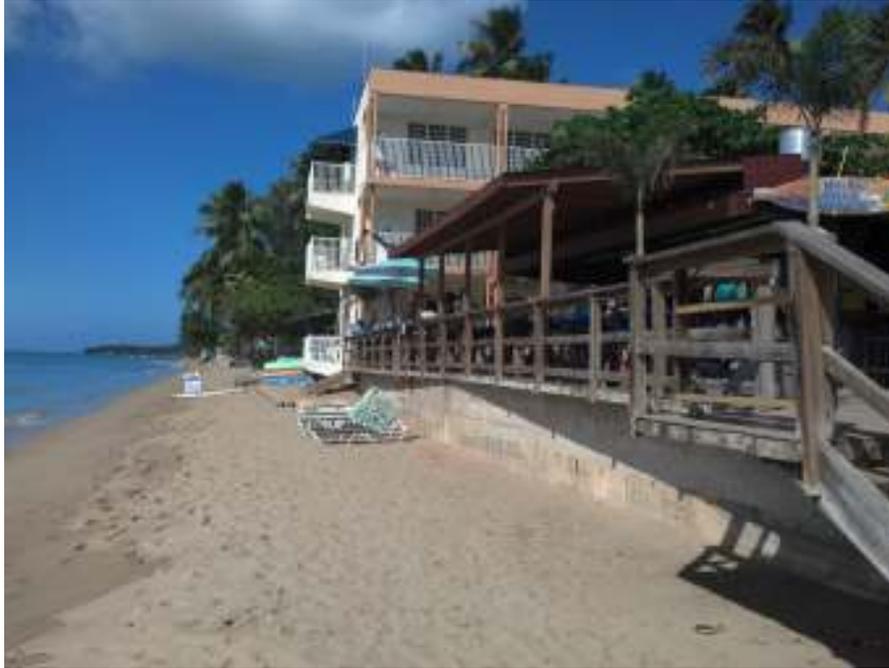
A1: Seawall constructed by Villa Cofresi Hotel (2012). Photo: P. Mejías.

composed by rocky material (Thieler et al. 2007). Sampling off this point indicates that much of the sand is moving offshore at Punta Cadena (Thieler et al. 2003). Some of this sand is transported as suspended sediments and then is added to the Añasco beach. So, we can interpret that Rincon Beach is being eroded by natural and man-made changes. 2007 terrestrial pictures show the abundance of sand in the beach. By 2008, Villa Cofresí Hotel administration had to construct a sea wall and redesign their public bar area due to the fast erosional rate of the beach.

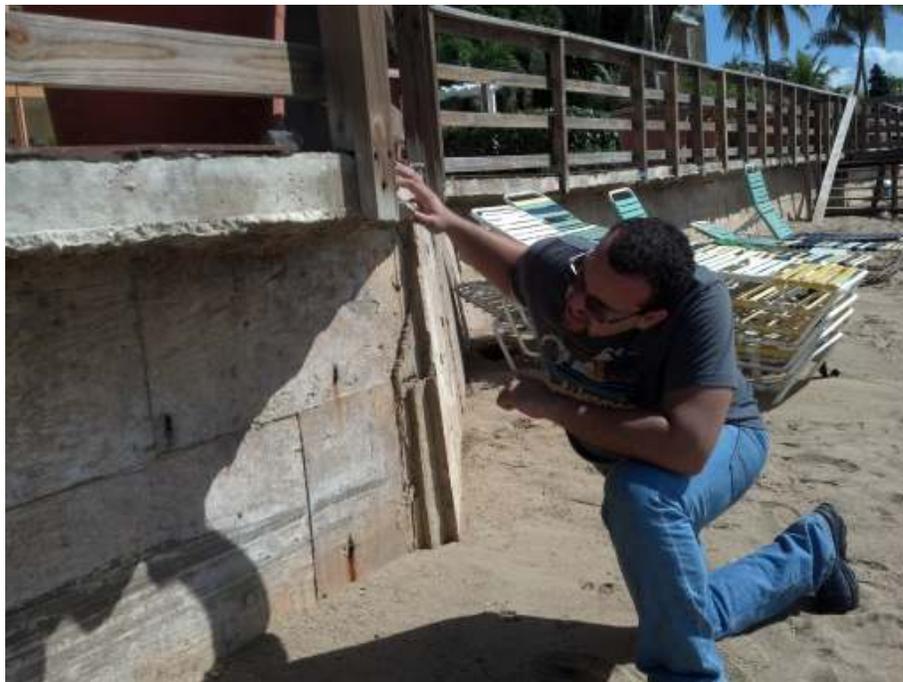
A2: Me observing the erosion of the 4 year-old sea wall. Photo: P. Mejías.

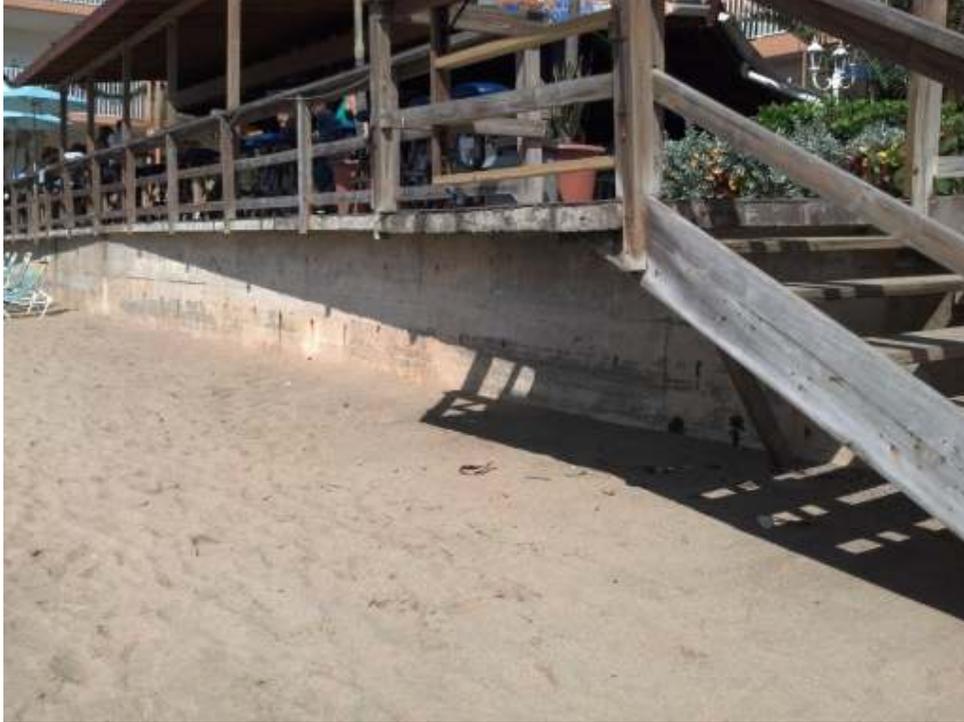
A3: Close up detail of the concrete wall. Photo: P. Mejías.

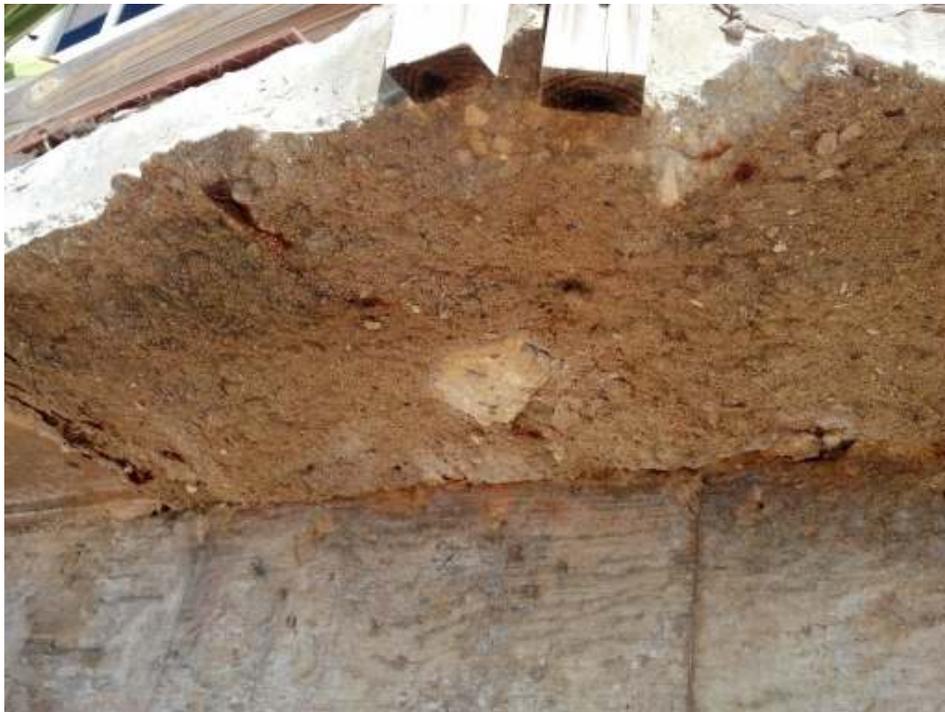
A4: Concrete wall erosion. Photo: P. Mejías.

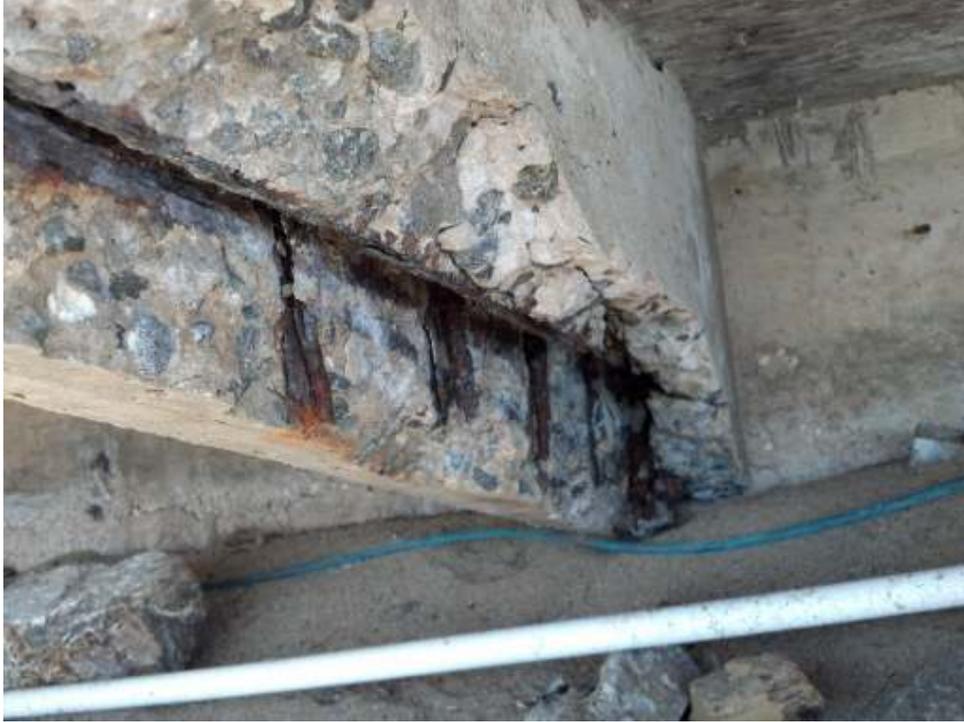
A5: Recent damage to the concrete wall . Photo: P. Mejías.

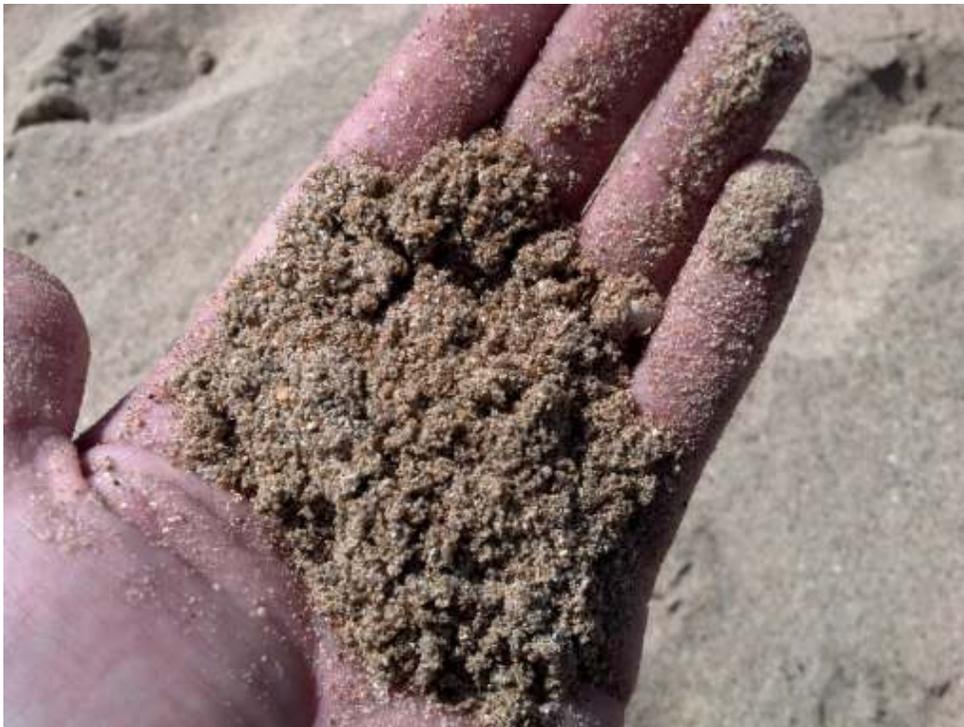
A6: Grain size detail. Photo: P. Mejías.

Rincon beach sands are composed by carbonates, quartz, and lithic materials with a low amount of feldspar. Grain size ranges from medium to fine based in the sample collected at the berm at the middle of this transect. The beach is extended from north to south where the shoreline is

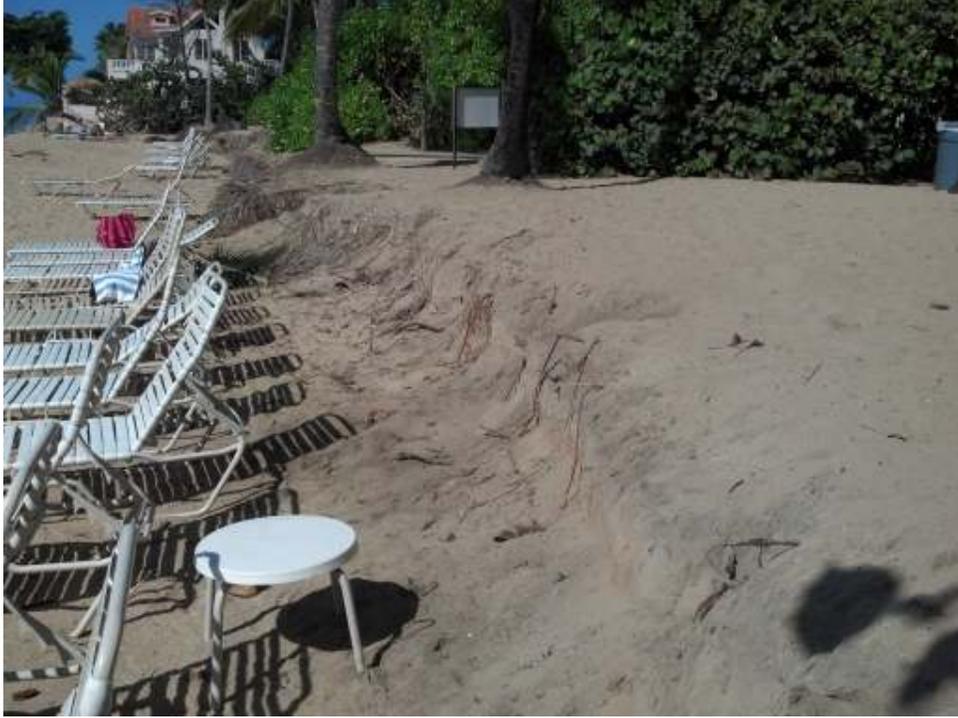
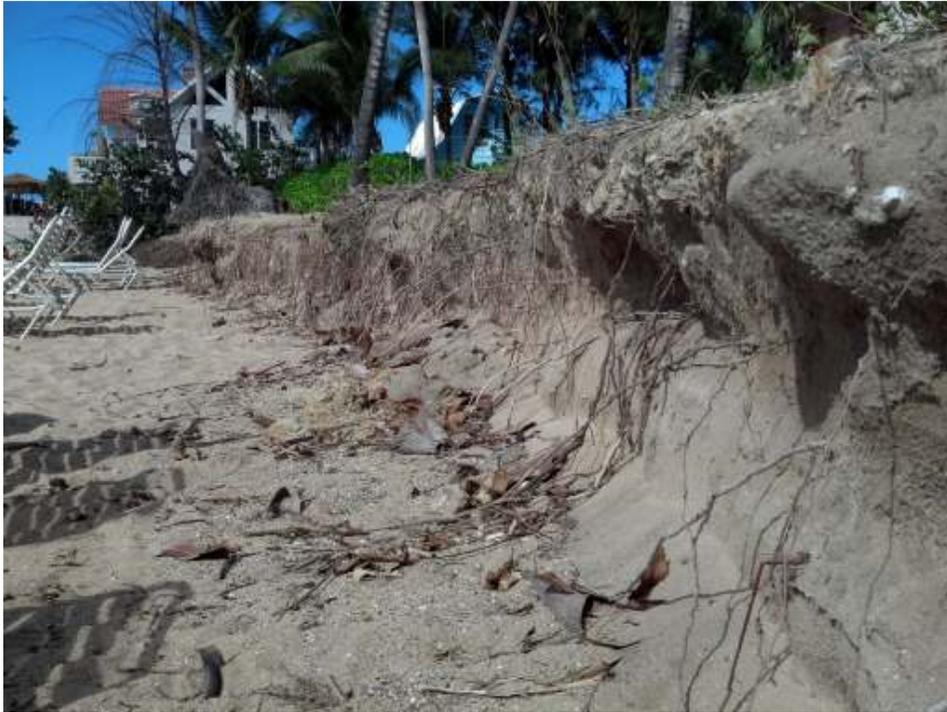
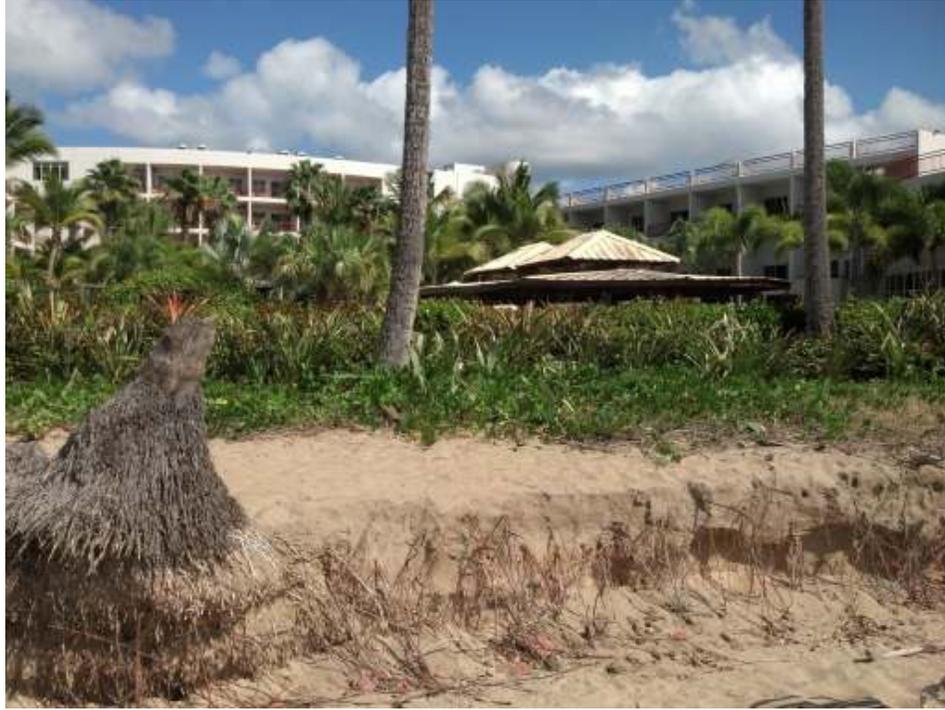
A7: Erosion of sand behind Rincon of the Seas Hotel. Photo: P. Mejías.

A8: Erosion of sand behind Rincon of the Seas Hotel. Photo: P. Mejías.

A9: Erosion of sand behind Rincon of the Seas Hotel. Photo: P. Mejías.

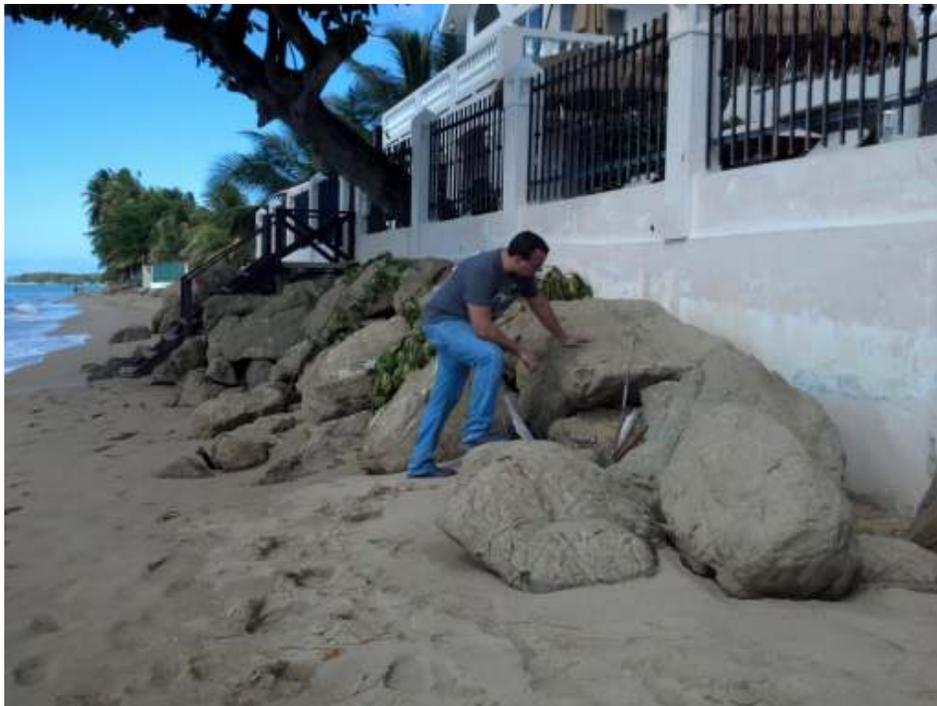
A10: Sea wall rocks to control erosion. Photo: P. Mejías.
